ITAIPU HYDROELECTRIC PROJECT

Engineering Features

ITAIPU BINACIONAL
1994

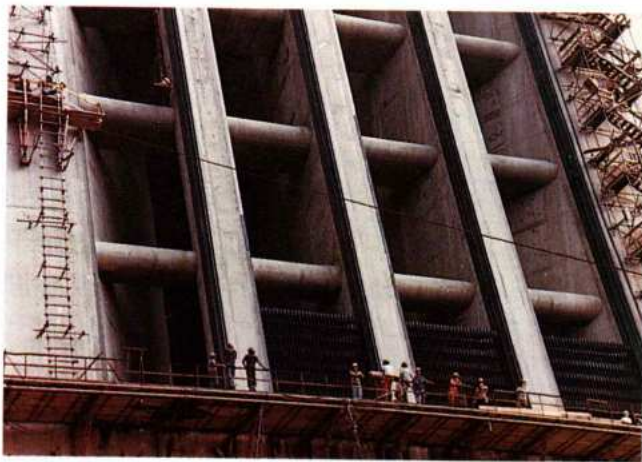
Blockouts were left in the first stage concrete for the mild steel guides, which were subsequently embedded in second stage concrete. Embedded steel plates, positioned at intervals in the first stage concrete, facilitated the erection of the guides. The guides position not only the trashrack panels and lifting beam but also the

Installation of the trashracks in the intake

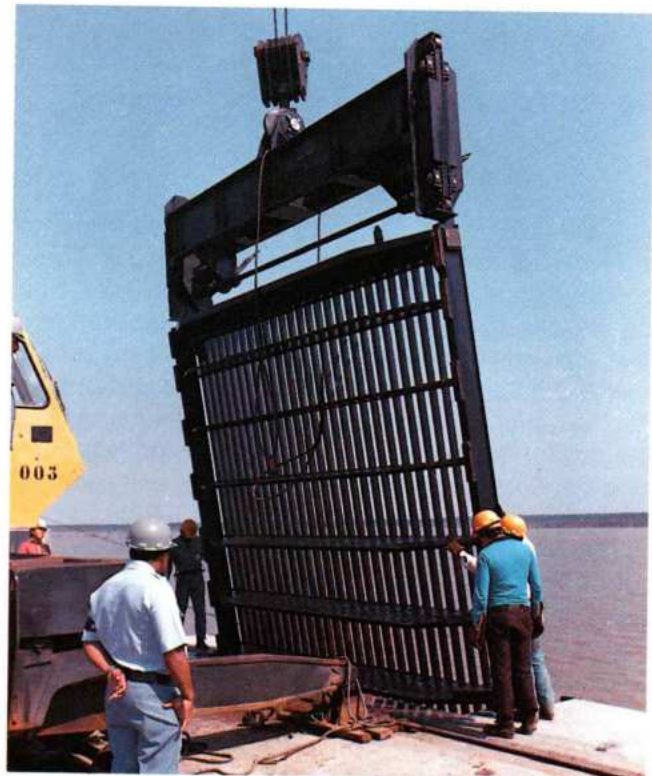
Fig. 10.4 View of lifting beam

grab of the trashrack cleaning machine and were erected to an accuracy of $+1/-3$ mm on the guiding surface before embedment. Two wheels on each side of the lifting beam run in the guides and the hooks of the beam either engage or release a panel depending on the position of the hand-operated counterweights, see Fig.10.4.

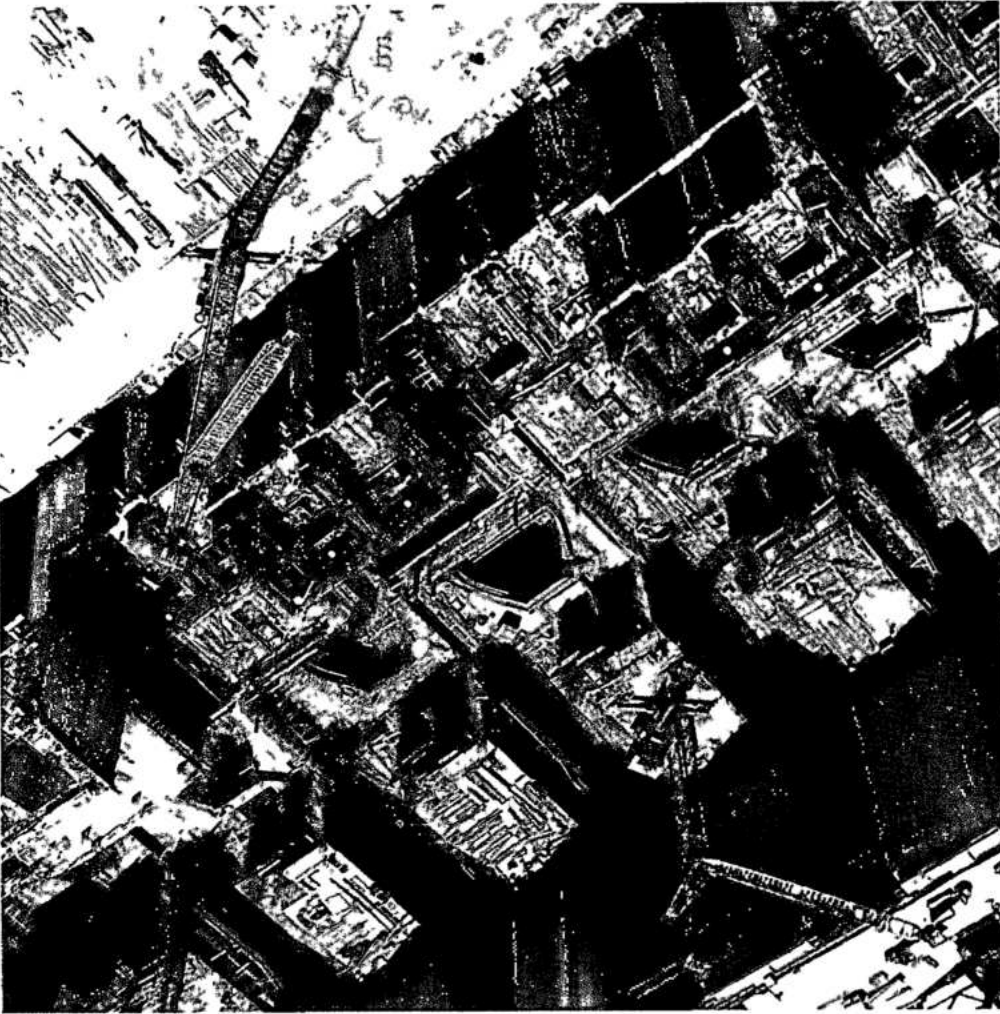
Backfill concrete below El. 54. In the central part of the powerhouse, over an area approximately 155 m x 45 m, the bedrock was 5 to 20 m below El. 54, the lowest nominal foundation of the powerhouse. Considering the large volume of backfill concrete required, it was decided that the concrete would be placed continuously without any contraction joints or treatment of joints between layers.

The concrete was delivered in dump trucks, placed at 6 m intervals and spread by bulldozers in 0.5 m layers. Compaction and consolidation of concrete was with backhoes with internal vibrators. Some immersion type vibrators were also employed. Concrete placement averaged 15 000 m³/day.

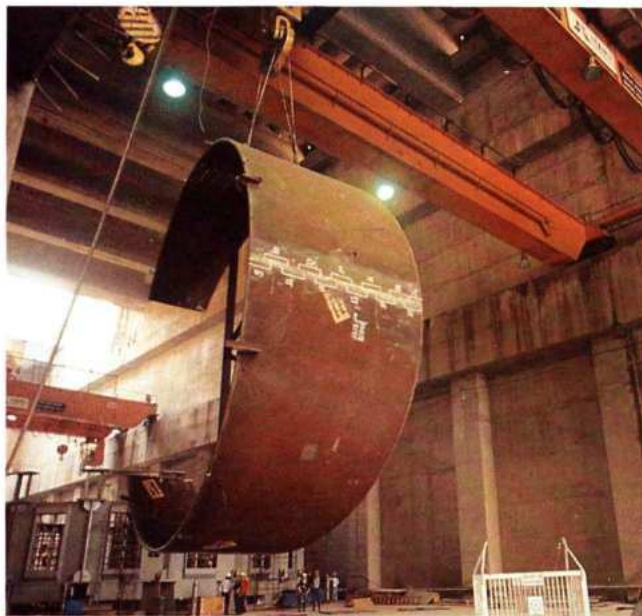
Transport of spiral case segment along powerhouse

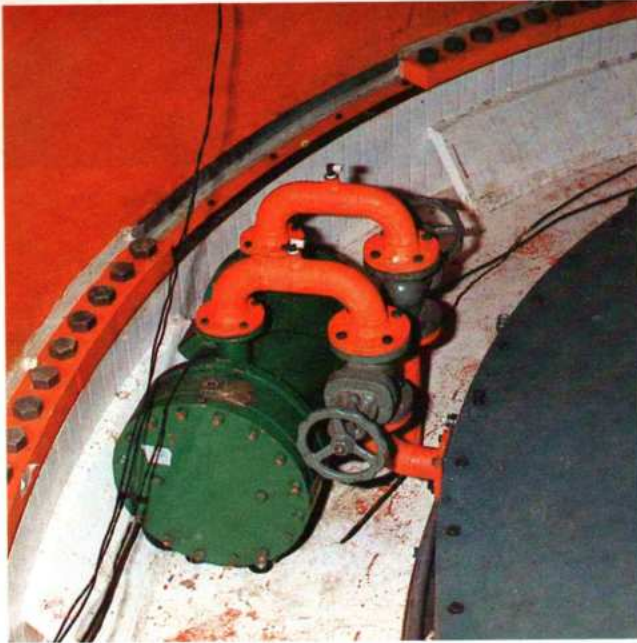
The bearing is equipped with high/low oil level switches, pad and oil temperature transducers, "water-oil" transducers and cooling water flow switches.

Turbine guide bearing

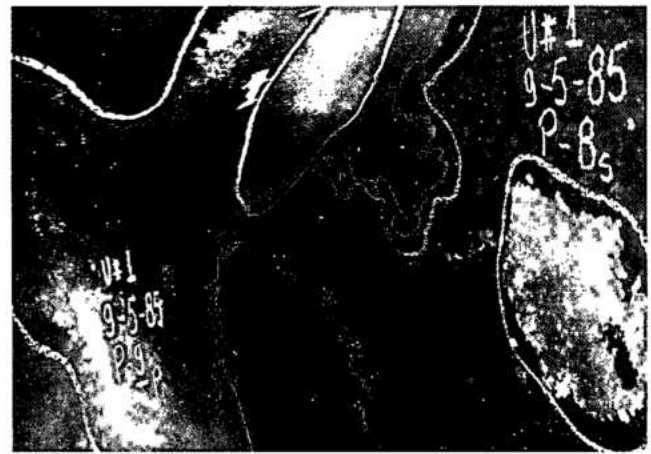
| 1 Depression along the profile in the blade outlet area | 3 Implosion area |
| 2 Vortex imploding in the fluid area | 4 Vortex attachment area |

Cavitation damage

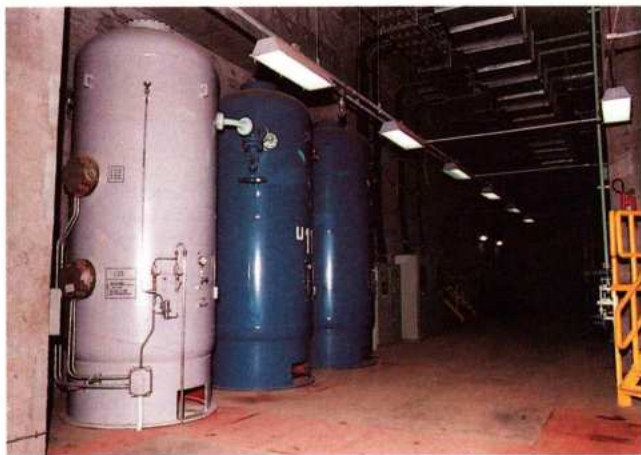
Hydraulic positioner

Mounted on the tank of the pumping set, are the actuator, the shut down valve, and the distributing valve. Oil under pressure is supplied from the pressure tanks which are kept charged by the oil pumping set.

The pressure tanks auxiliary receiver and pumps are equipped with pressure relief valves. The supply pipe from the oil/air pressure tank has a quick acting valve which closes in response to a low oil level switch in the tank, to prevent air entering the system. Leakage oil from the main servomotors is collected in a small sump tank and pumped back to the pumping set sump tank.

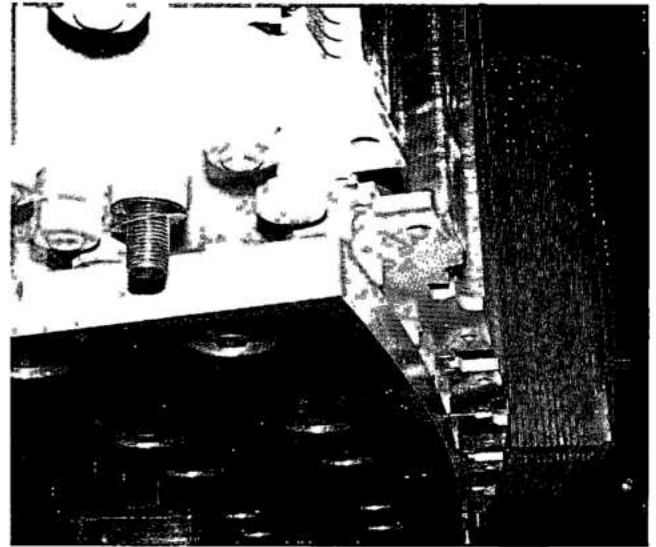
Detail of brake ring on underside of rotor.
Note seating nuts and holding studs

Maximum axial deflection of the rotor relative to the thrust bearing is 1.15 mm. With the shrunk on design the maximum combined stress of 162 N/mm^2 occurs at stand-still. Stresses in all other operational cases, including runaway speed, are less as the prestress is relieved by the centrifugal forces. A sectionalized steel plate brake ring having a hardness of $175 \pm 25 \text{ HB}$ is bolted to the bottom of the rotor rim.

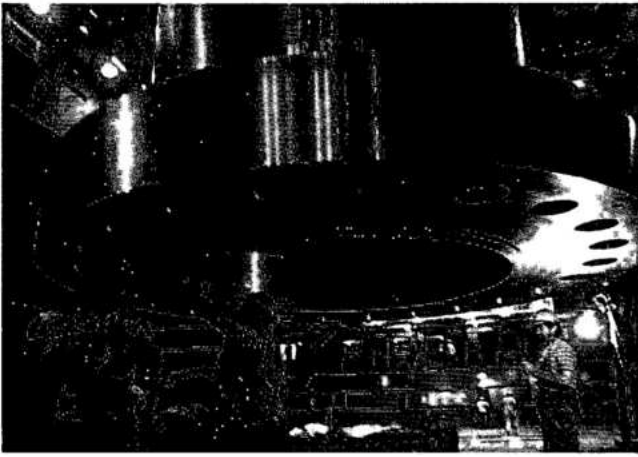
Fig. 12.61 Generator lower shaft

Generator lower shaft undergoing cleaning and visual inspection before coupling to turbine shaft

The upper shaft is divided in two parts, the upper collar being insulated electrically from the lower part, see Fig 12.60. The lower part of the upper shaft was made from a single forging, whereas it was more convenient to make the lower generator shaft by welding two forged flanges to the forged central cylinder, see Fig. 12.61.

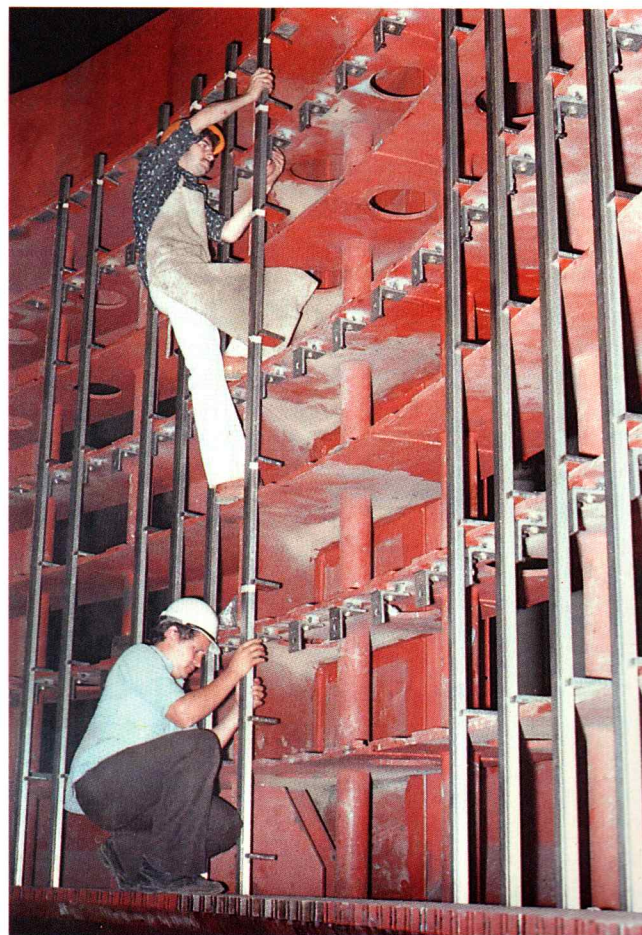
Installation of stator core guides

In preparation for stacking the stator core, the bottom clamping fingers and the vertical dovetail key-bars were installed. The clamping fingers were levelled and welded and a trial fit of core laminations made to the key-bars. The key-bars were aligned and their keeper plates welded.

Stator core stacking was done in eight stages, each consisting of approximately seven core packs. At the end of each stage the core was hydraulically pressed, the height and inside diameter checked and if necessary the key-bars adjusted to maintain the design diameter to ± 0.7 mm. On completion, the stator core was given a magnetization test.

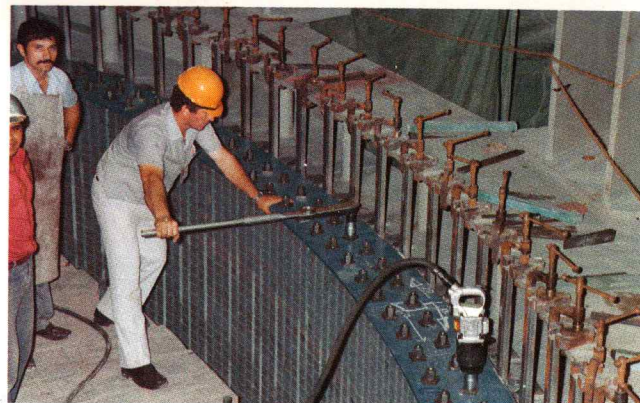
Installation of stator winding. Insertion of side filler (BBC generator)

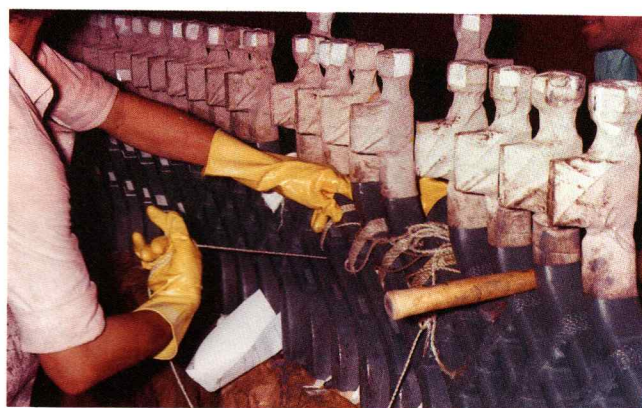
Lashing of upper bars

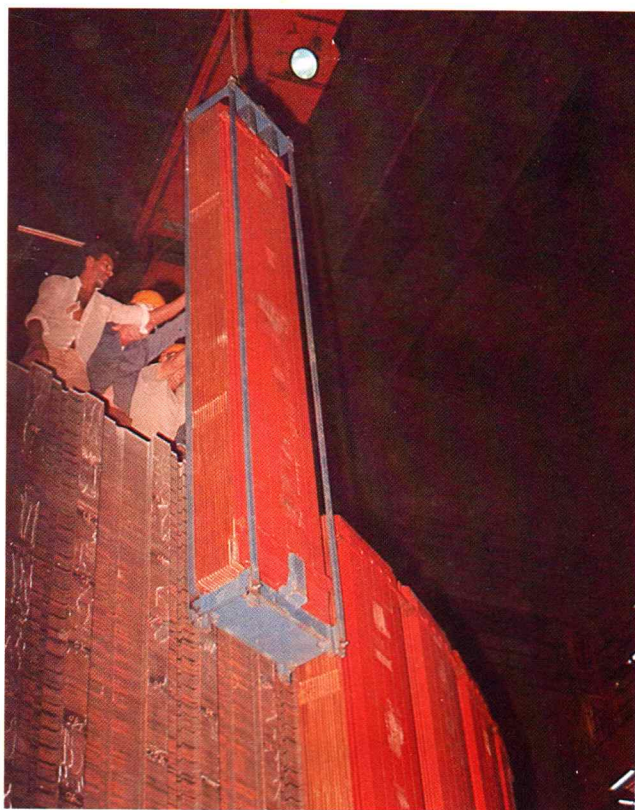
Rotor arms ready to be lifted on the supports and welded to the central hub

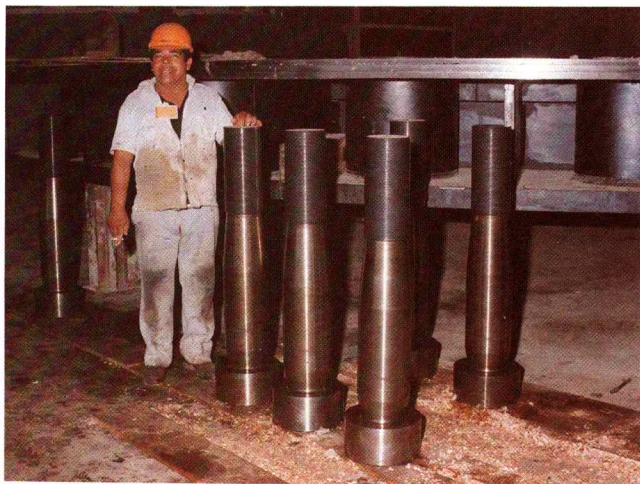
Lower generator and turbine shaft coupling

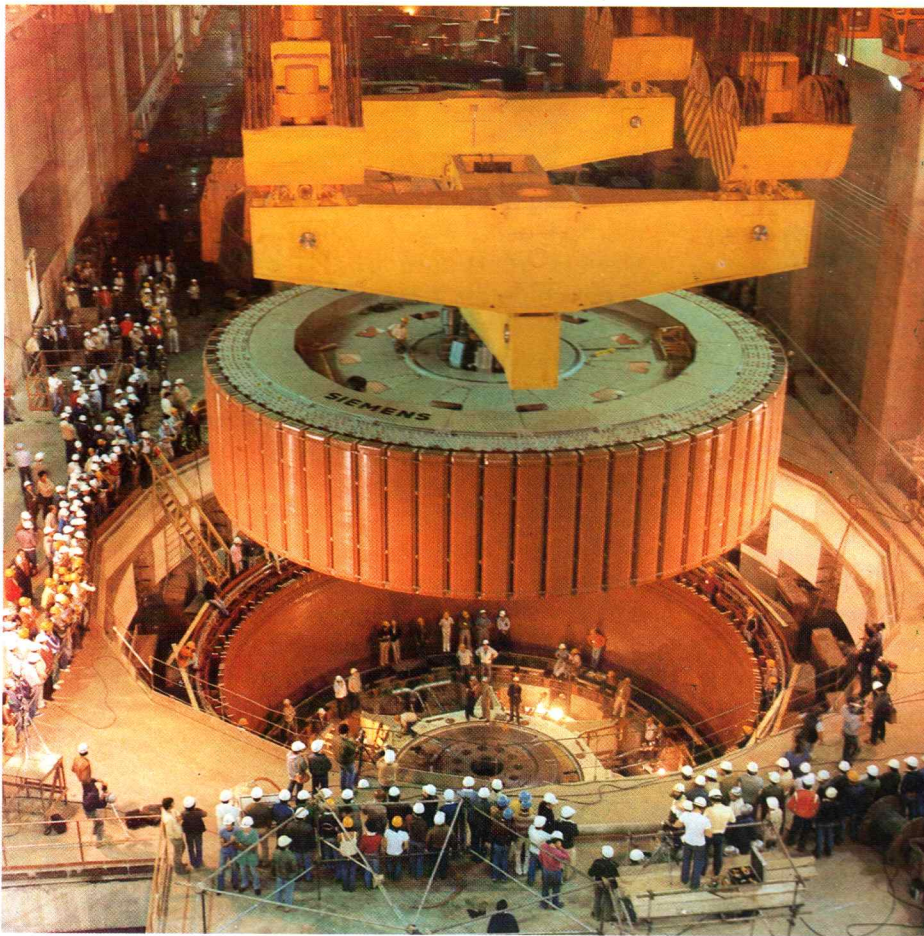
Lowering of rotor onto generator lower shaft

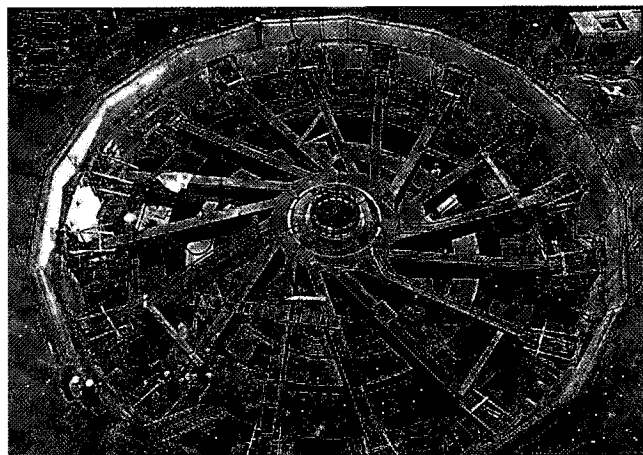
Upper bracket during erection

The bracket is fabricated from mild steel welded plate. It transmits the upper bearing loads to the concrete and also supports the slip ring enclosure and the turbine aeration valve. The sixteen arms of the upper bearing bracket are in the horizontal plane, at an angle to the radial direction, see Fig. 12.66. With the skewed design, thermal expansion of the arms causes a slight rotation of the bracket hub, and thus minimizes the influence which the expansion has on the bearing center and the clearance. The connection of the arms to the stator frame is by the upper oblique plates which isolate the expansion of the stator frame from the upper bracket and thus prevents these movements from affecting the upper bearing clearances.

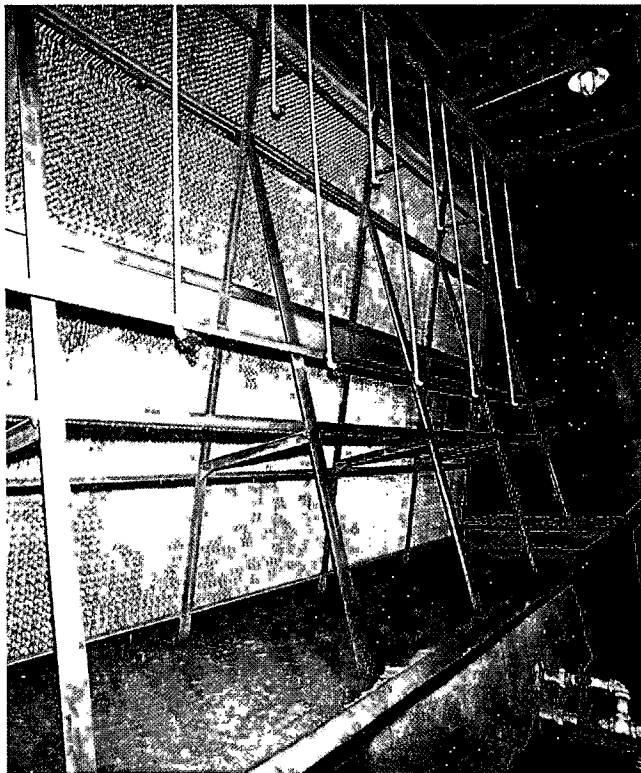
Venetian blind array of evaporative cooler and water spray system

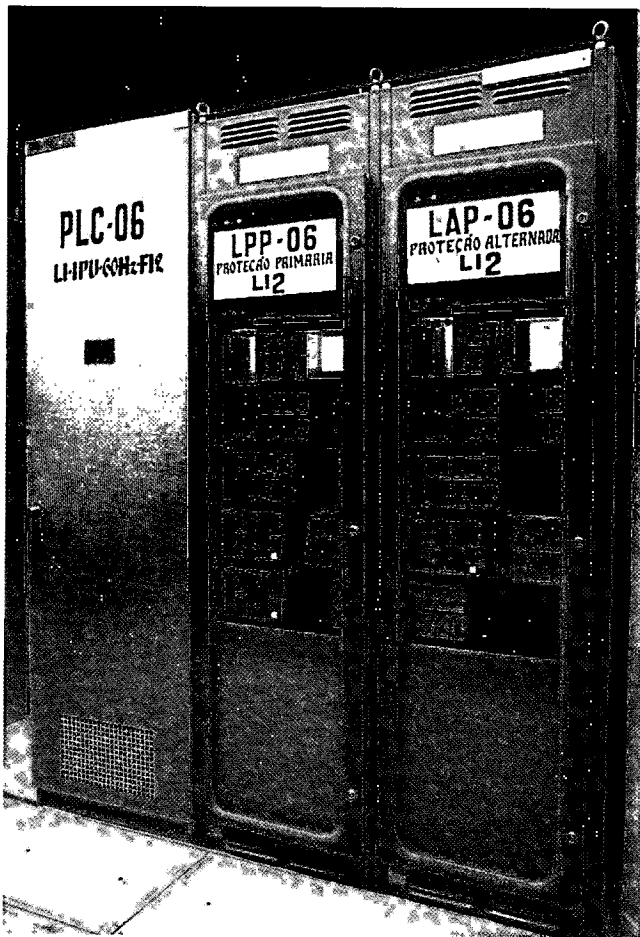
Fig. 14.13 500 kV Transmission lines (50 Hz) primary and alternate protection panels

The line protection cubicles are located in the GIS gallery close to the line circuit breakers, see Fig. 14.13.

The fiber optic link for the differential (87P) is redundant and has two routes, one aerial and the other underground. In case of a fault on the line, the primary protection trips both line terminals through a direct transfer trip signal through the fiber optic communication link. The fiber optic signal is continuously monitored, and an alarm occurs if the signal is lost or drops below acceptable level.

The alternate protection system is a permissive overreaching unblocking transfer trip scheme actuated by a distance relay (21A), which uses the power line carrier communication link as the teleprotection channel.

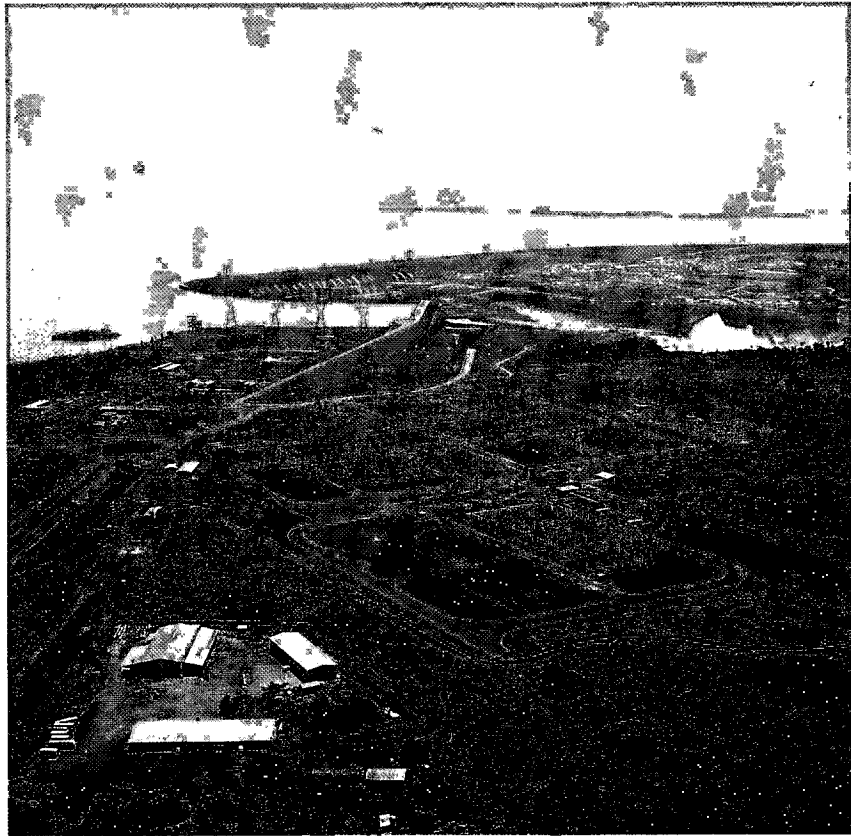
Aerial view of right bank substation

bay. This allows the direct through connection of the lines if necessary. In fact, in the initial arrangement two of the lines by-passed the substation altogether. The breaker-and-one-half scheme is arranged with an inverted bus, that is, with the main bus located centrally to the line and transformer take-off structures. This arrangement avoids three conductor levels but requires a considerable increase in bay width making it more expensive. Nevertheless it was chosen because of the foreseen future changes in the number of the incoming and outgoing 500 kV circuits. The adopted arrangement, placing the heavy main buses at the lowest level and reducing the overall height, had the additional benefit of improving the aesthetics and reliability.

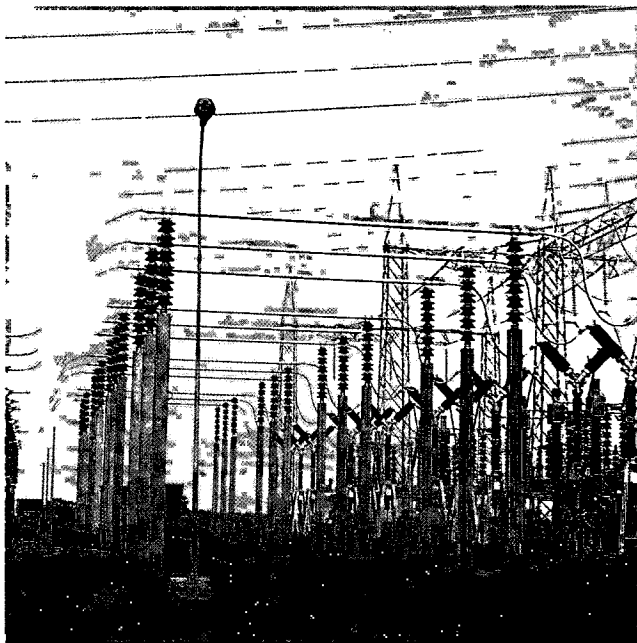
Partial view of 500 kV switchyard

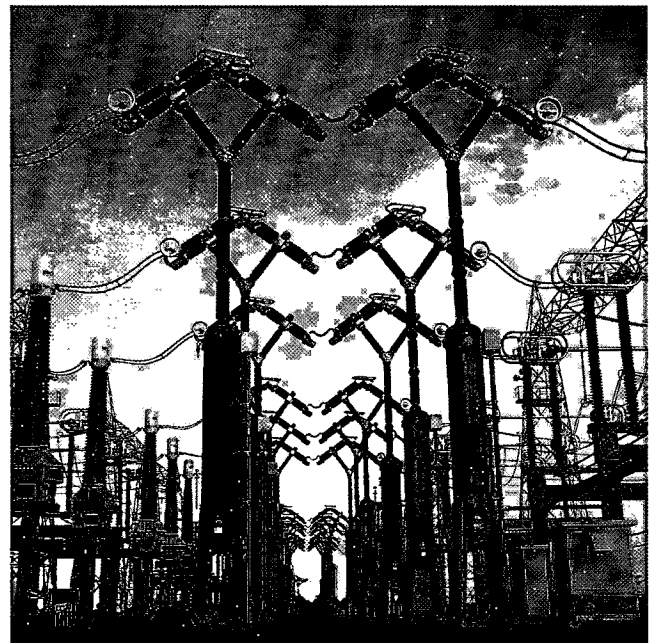
500 kV circuit breaker

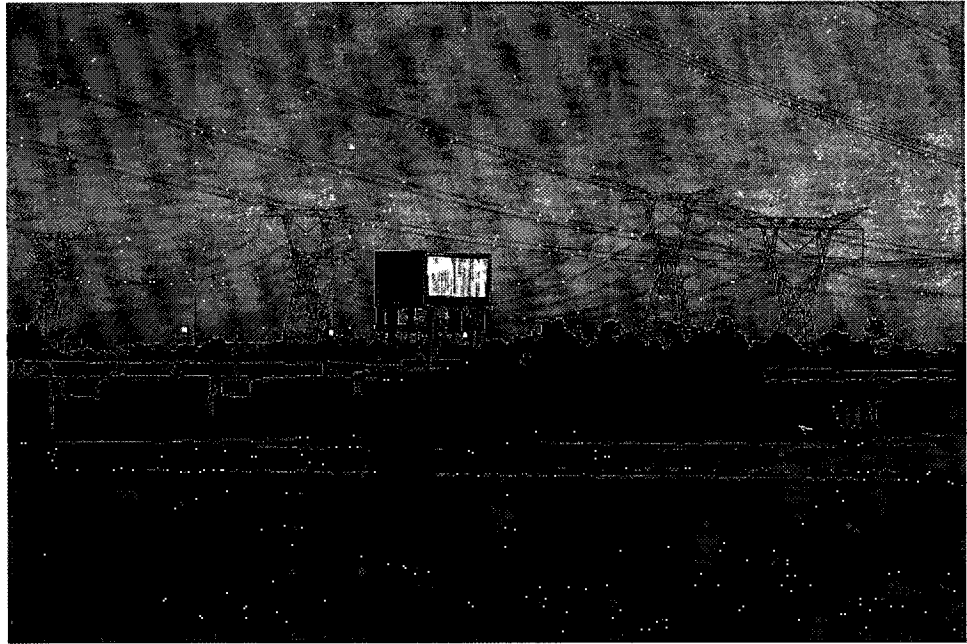
500 kV transmission line tower (on top of the right wing buttress dam)

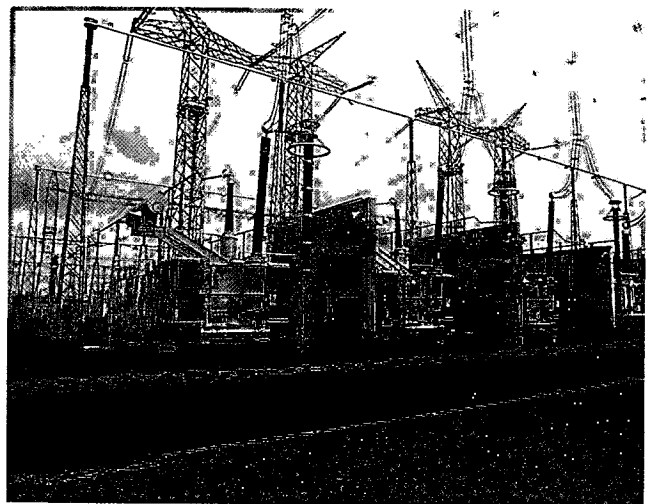
Partial view of 765 kV switchyard

Three of the four overhead lines from the autotransformer area are paired with 765 kV transmission lines on a breaker-and-one-half bay. The fourth line is connected in a double breaker mode in a fourth bay which can be converted if another line position is required.

The bay width is 45 m with a 39 m separation between the second and third bays for an access road, relay building and stand-by emergency generator building.

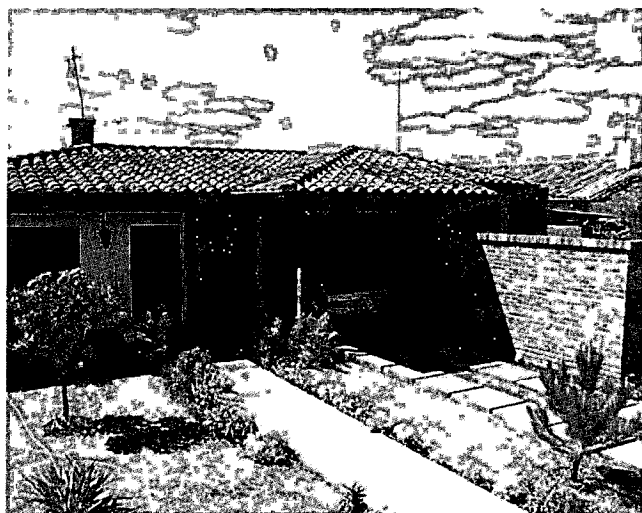
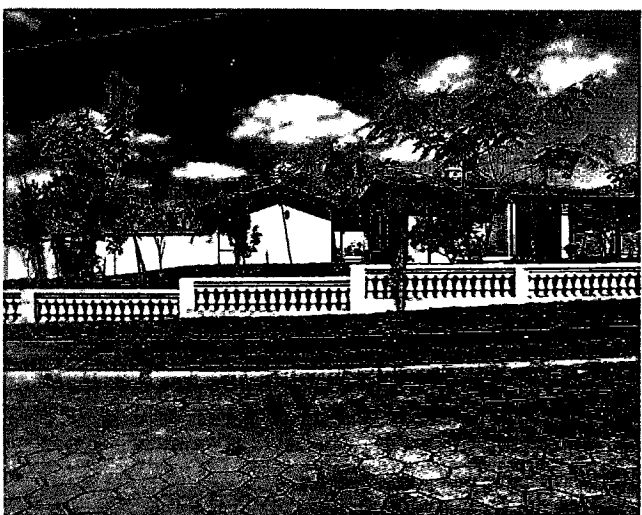
Views of typical Itaipu houses
